Home Inspection Services, LTD
32 Long Meadow Dr.
New City, 10956

Your Home Inspection Report

Mr. and Mrs. Smith
1234 Anywhere St.
Anytown NY 12345

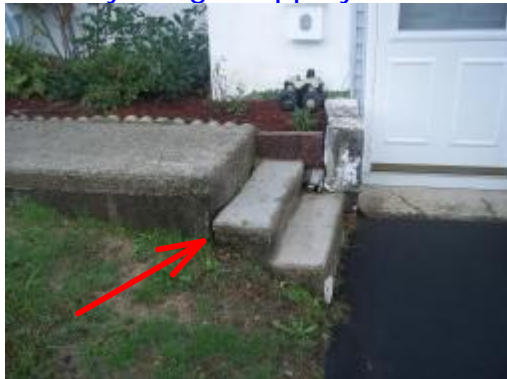
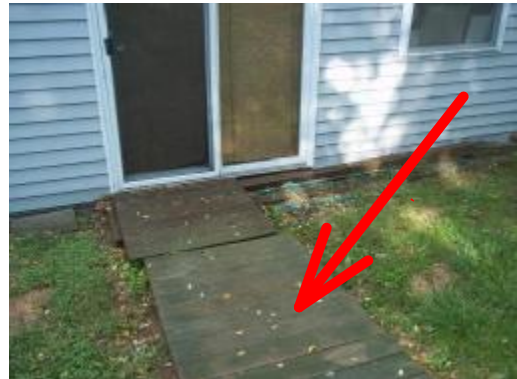
1. Marginal Walks: Concrete, Wood **Settlement crack may pose a tripping hazard. Walk walkway can get slippery when wet.**

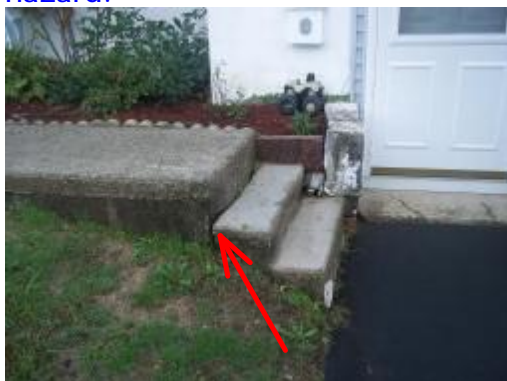
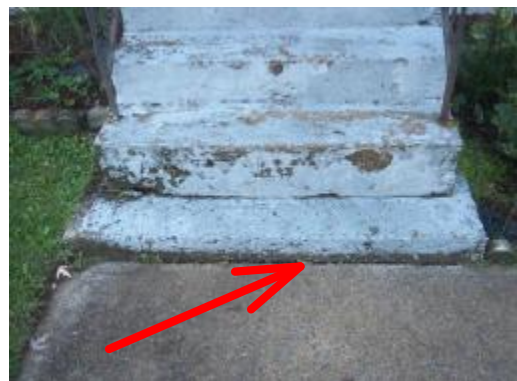
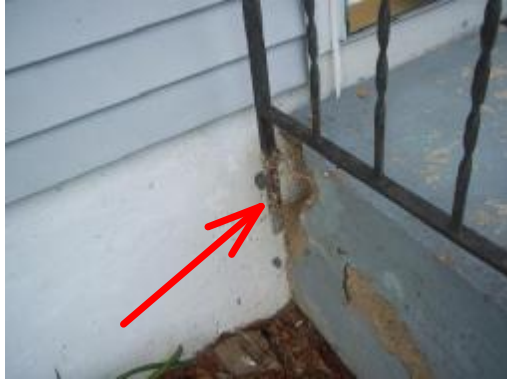
Steps/Stoops: Concrete **Missing handrails. Front entrance railing is broken. The different heights that make up the front steps can cause a tripping hazard.**

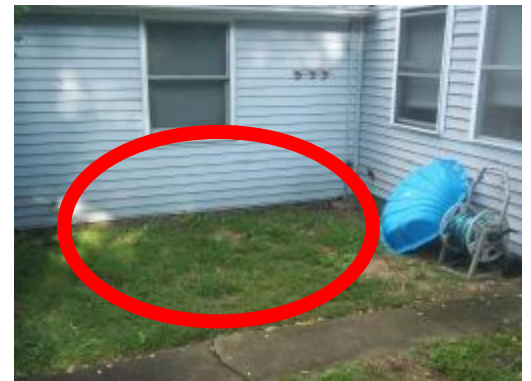
Deck: Treated wood, (Rear)
Grading: Grading on the rear of the home should be adjusted to help divert water away from the home.
Adding additional grading to the foundation will help keep water away.

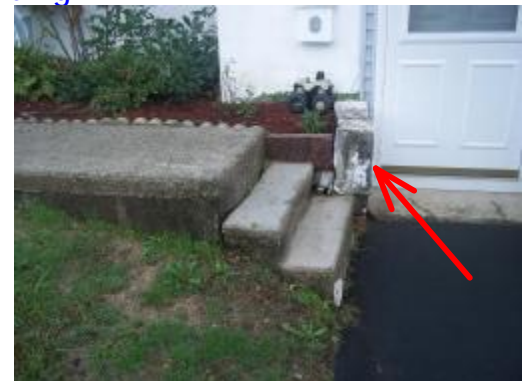
Vegetation: , Shrubs All foliage should be trimmed away from the home and there should be a 15" spacing to protect siding.
Retaining Walls: Concrete Retaining wall requires repair. Contact contractor.

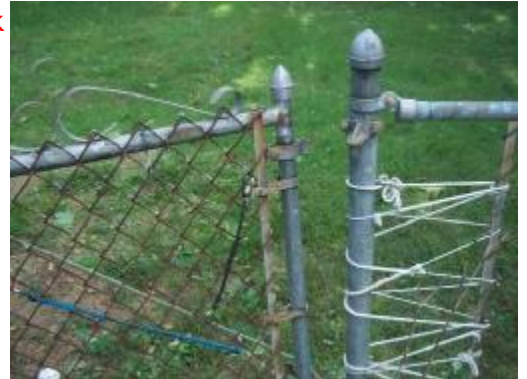
7. Defective Fences: Chain link **Parts of the chain link fence are damaged and require repair. Repair gate.**

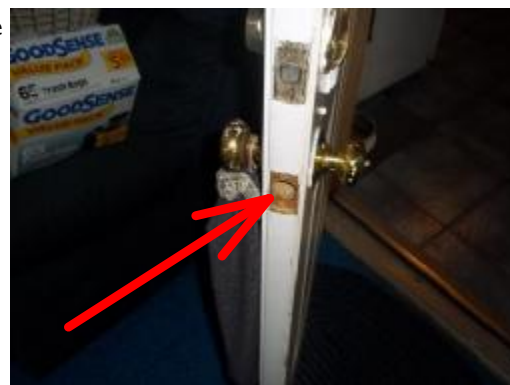
- 1. Acceptable Type: Vinyl siding
- 2. Acceptable Trim: Aluminum
- 3. Acceptable Fascia: Aluminum
- 4. Acceptable Soffits: Vinyl
- 5. Defective Door Bell: Hard wired **Inoperative**
- 6. Acceptable Entry Doors: Metal, (Frt.), (Rear) The lock set on the rear door is missing and should be replaced.

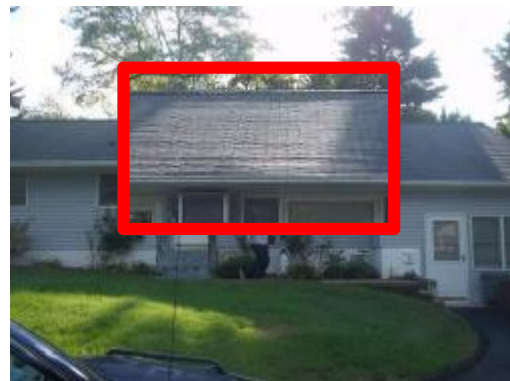
1. Method of Inspection: Ground with binoculars
2. Acceptable Unable to Inspect: Fully visible
3. Marginal Material: Asphalt shingle Signs of curling or cupping

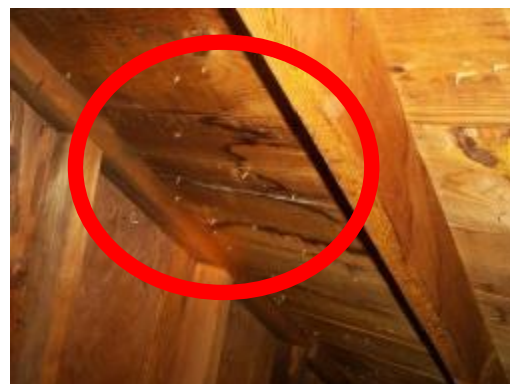
1. Method of Inspection: In the attic
2. Acceptable Unable to Inspect: 25%
3. Acceptable Roof Framing: 2x4 Rafter
4. Marginal Sheathing: Plywood **Water stains present**

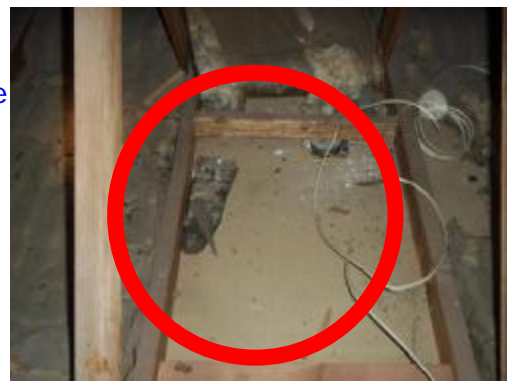
6. Marginal Insulation: Fiberglass **Insulation compressed, Insulation is blocking the soffit vents and should be moved to create better air flow.**

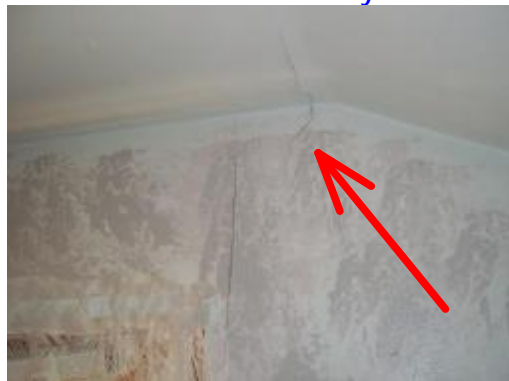
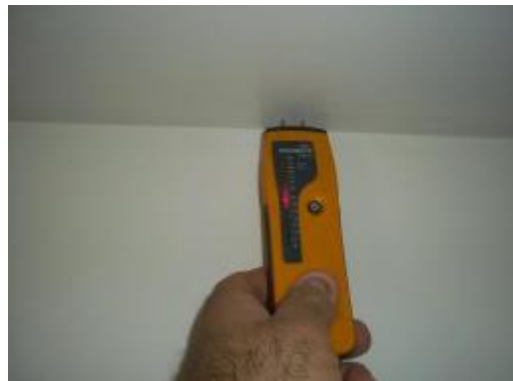
Ceiling: Sheetrock **Some minor cracks are present and considered cosmetic. Hi moisture readings were found at some locations on the sheet rock. Recommend evaluation by a contractor.**

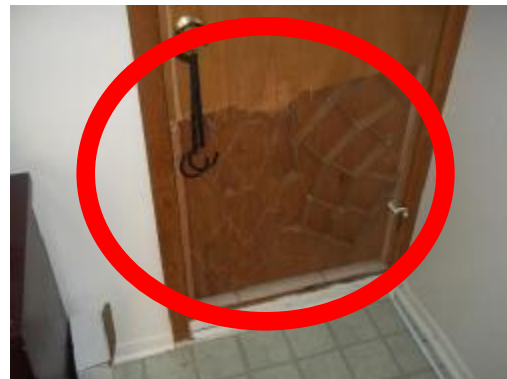
4. Marginal Doors: Hollow wood, Sliders **Door requires replacement.**

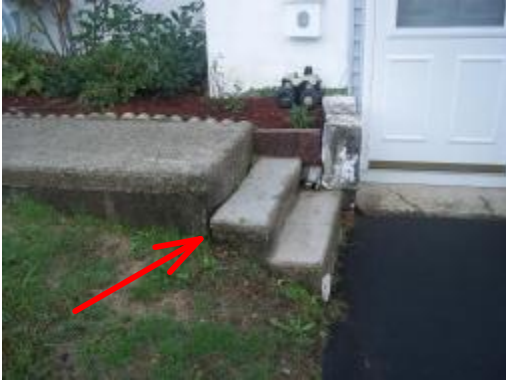
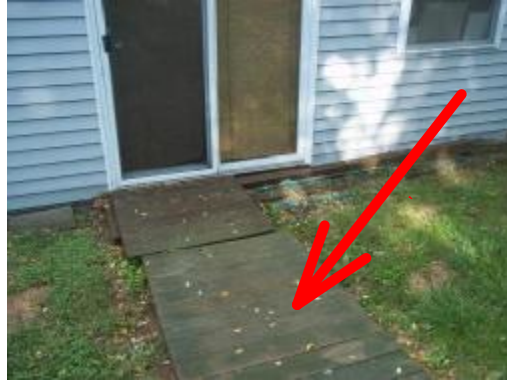
1. Walks: Concrete, Wood Settlement crack may pose a tripping hazard. Walk walkway can get slippery when wet.

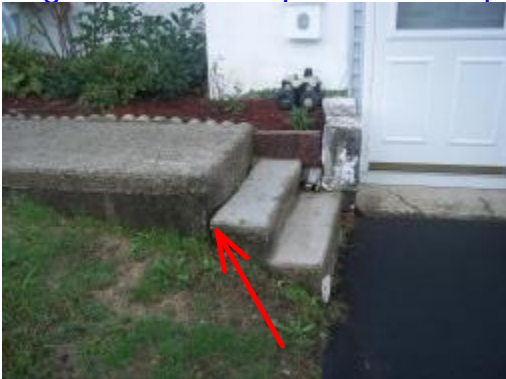
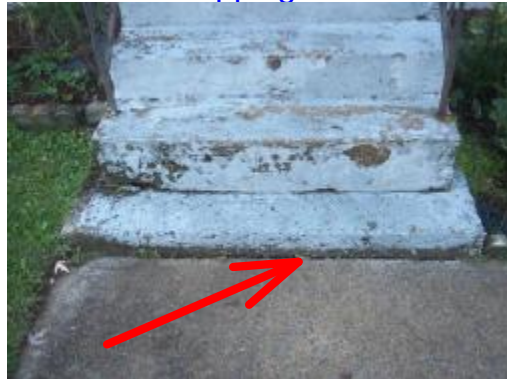
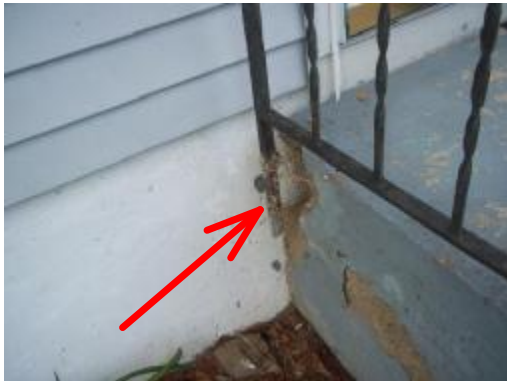
2. Steps/Stoops: Concrete Missing handrails. Front entrance railing is broken. The different heights that make up the front steps can cause a tripping hazard.

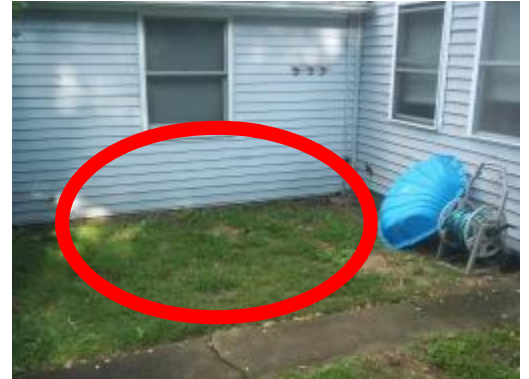
3. Grading: Grading on the rear of the home should be adjusted to help divert water away from the home. Adding additional grading to the foundation will help keep water away.

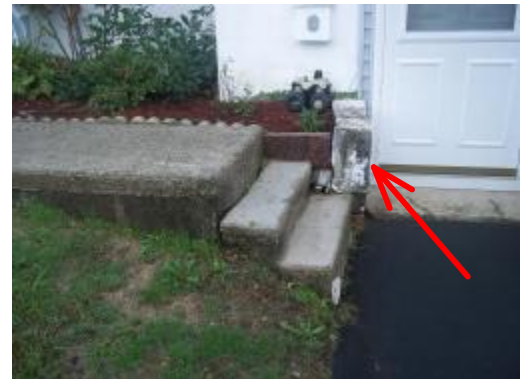
4. Vegetation: , Shrubs All foliage should be trimmed away from the home and there should be a 15" spacing to protect siding.
5. Retaining Walls: Concrete Retaining wall requires repair. Contact contractor.

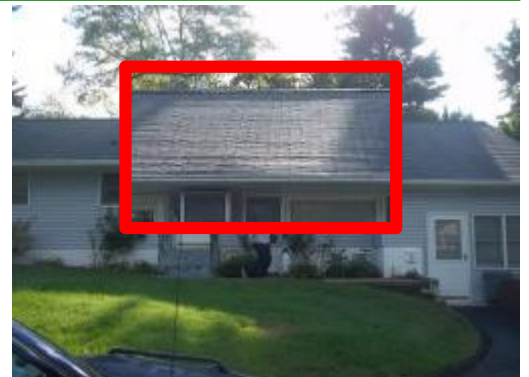
7. Main Roof Surface Material: Asphalt shingle Signs of curling or cupping

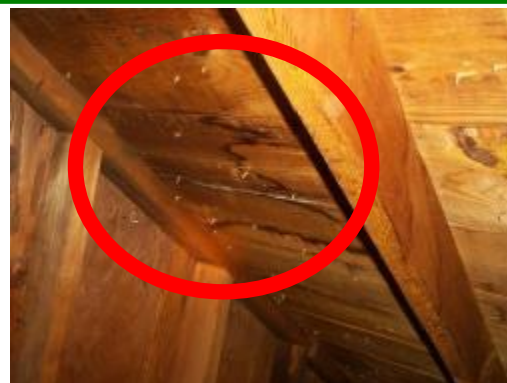
11. Main Attic Sheathing: Plywood **Water stains present**

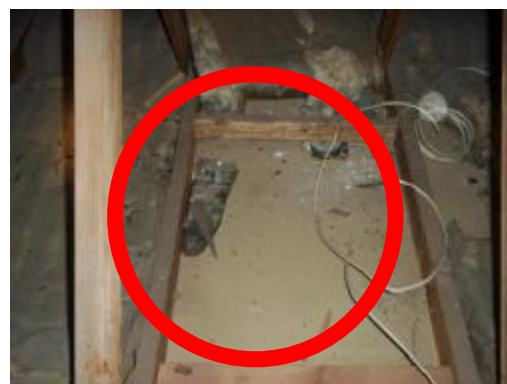
13. Main Attic Insulation: Fiberglass **Insulation compressed, Insulation is blocking the soffit vents and should be moved to create better air flow.**

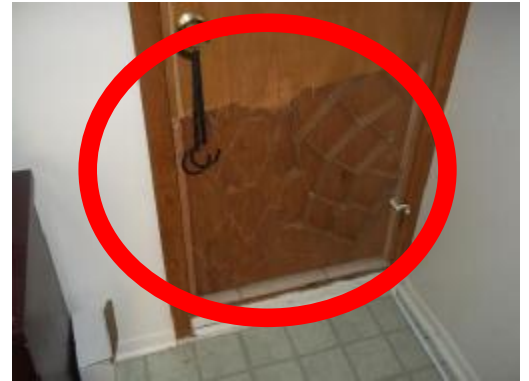
17. All rooms Living Space Doors: Hollow wood, Sliders **Door** requires replacement.

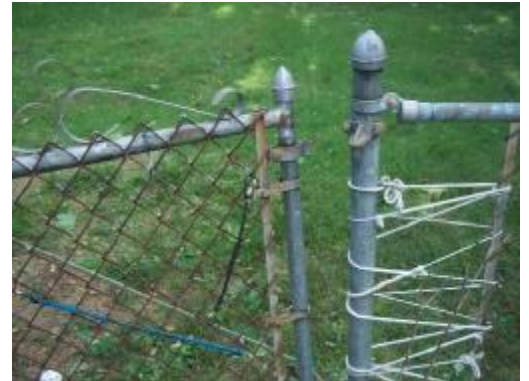
1. Fences: Chain link **Parts of the chain link fence are damaged and require repair. Repair gate.**
